## **Demonstration and Validation of Materials for Corrosion-Resistant Fencing and Guard Railings in Aggressive Climates**

Final Report on Project F09-AR02

Christopher Olaes, Richard G. Lampo, and Lawrence Clark

October 2015

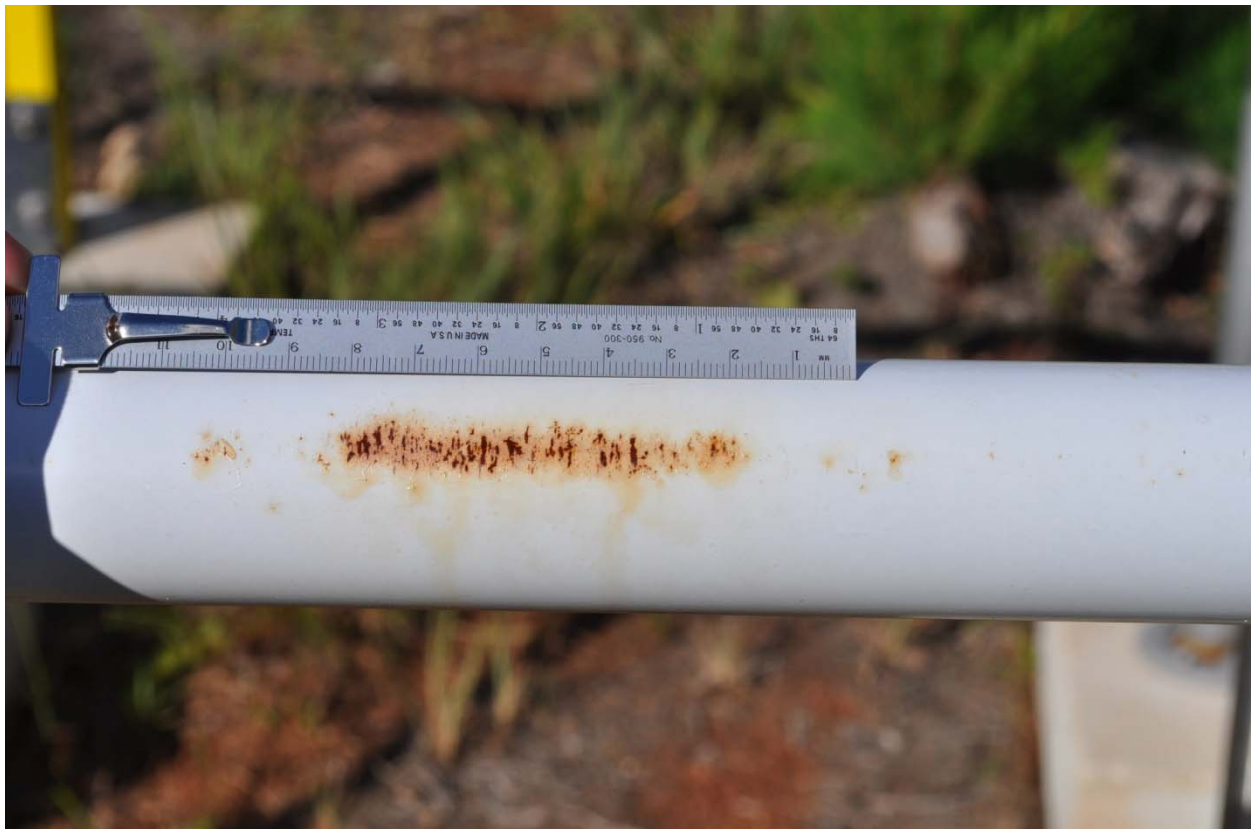
Aluminized Steel	20%	Oxidation	White oxidation of the zinc/AL coating 95% white corrosion on Galv. Hardware
	Fuse Bonded PVC Coated Galvanized	<5%	Rust	Minor rust has begun to form around cut ends and damaged areas
<b>Railing Coupons</b>	Stainless Steel	80%	Oxidation	Surface oxidation has discolored the material.
	Aluminum	<5%	Pitting	Pitting has begun in areas where the anodize may have been damaged
	Coated Steel	10%	Rust	Rust has begun to form where the coating has failed. Discoloring of the coating due to the rust.
	FRP	25%	UV	Discoloring due to UV exposure on the face of the railing that faces the sun
<b>Fabricated Railing</b>	Stainless Steel	50%	Oxidation	Surface oxidation has discolored the material. T-fittings show 90% surface corrosion likely due to lack of passivation.
	Aluminum	<5%	Pitting	Pitting has begun in areas where the anodize may have been damaged
	Coated Steel	10%	Rust	Rusting areas have spread larger causing blistering under the coating.

Figure B80. Coated Steel Railing

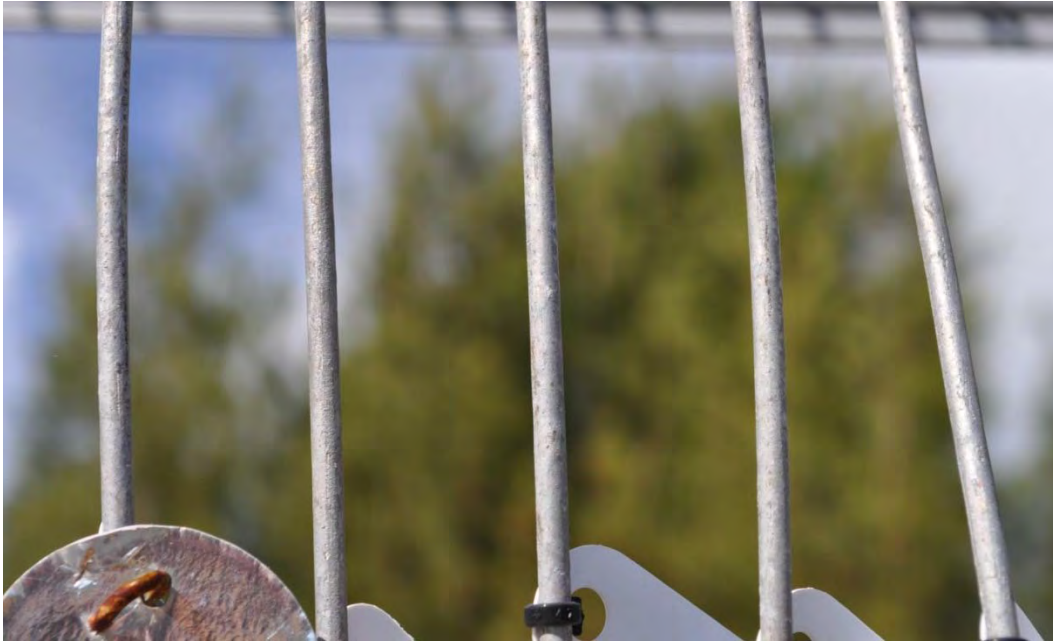
*Figure B88.* Aluminized Steel Wire Coupon

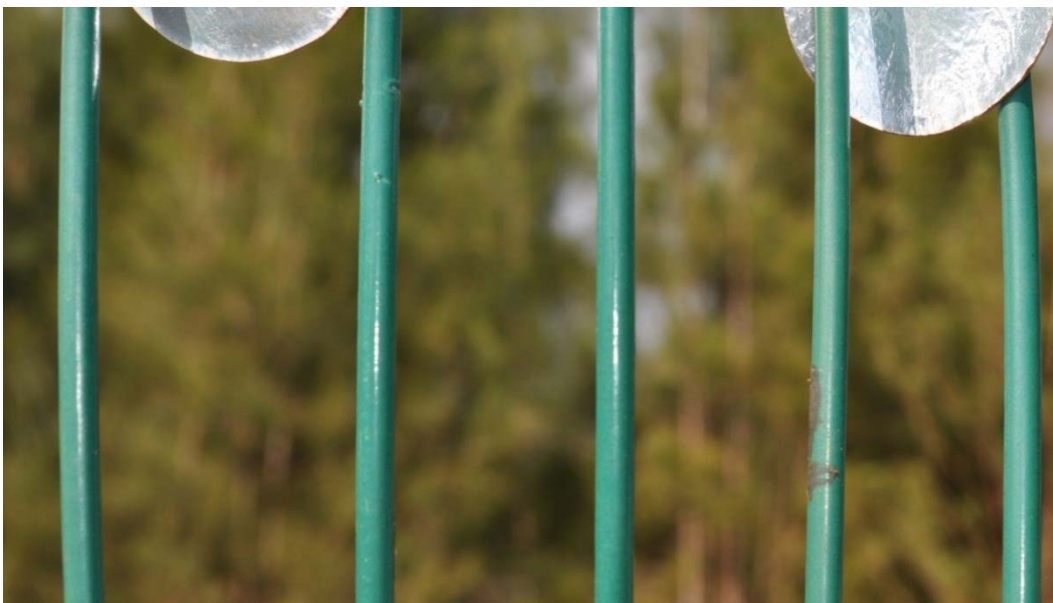
*Figure B90.* Fuse Bonded PVC Coated Galvanized Wire Coupon

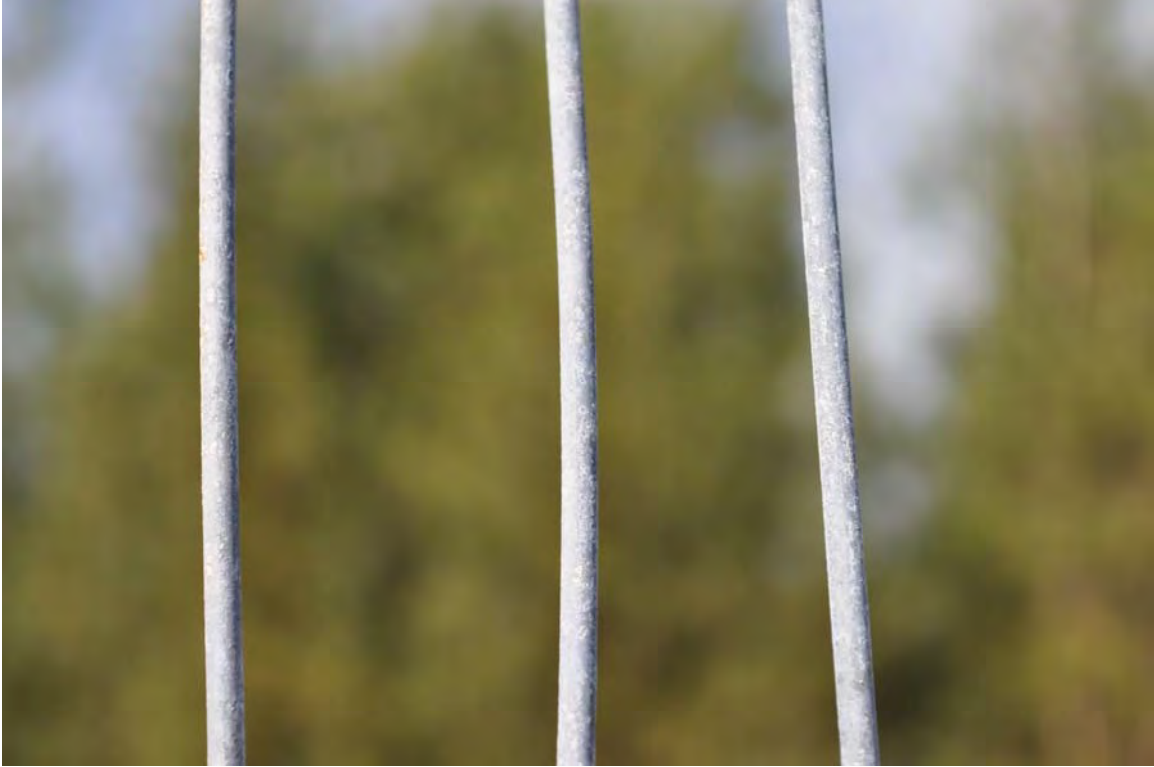
Visual Inspection Report				
<b>Date:</b> 10/4/2010 <b>Location:</b> Kahuku, HI <b>Exposure Period:</b> 6 Months				
	Material	% of Surface Corroded	Type of Corrosion	Notes
<b>Fence Wire Coupons</b>	Standard PVC Coated Galvanized	0%	N/A	No visible corrosion
	Fuse Bonded PVC Coated Galvanized	0%	N/A	No visible corrosion
	Standard Galvanized	50%	Oxidation/ Rust	50% of the corrosion areas have degraded past the sacrificial zinc coating and have begun to rust.
	Stainless Steel	100%	Oxidation	Surface oxidation
	Aluminum	5%	Pitting	Minor pitting
	Galfan	50%	Oxidation/ Rust	50% of the corrosion areas have degraded past the sacrificial zinc coating and have begun to rust.
	Aluminized Steel	<5%	Oxidation	White oxidation of the zinc/AL coating
<b>Fabricated Fencing</b>	Stainless Steel	75%	Oxidation	Surface oxidation has discolored the material
	Aluminum	5%	Pitting	Pitting more prevalent on the posts
	Galfan	80%	Oxidation	White oxidation of the zinc/AL coating

*Figure B96. Galfan Wire Coupon*

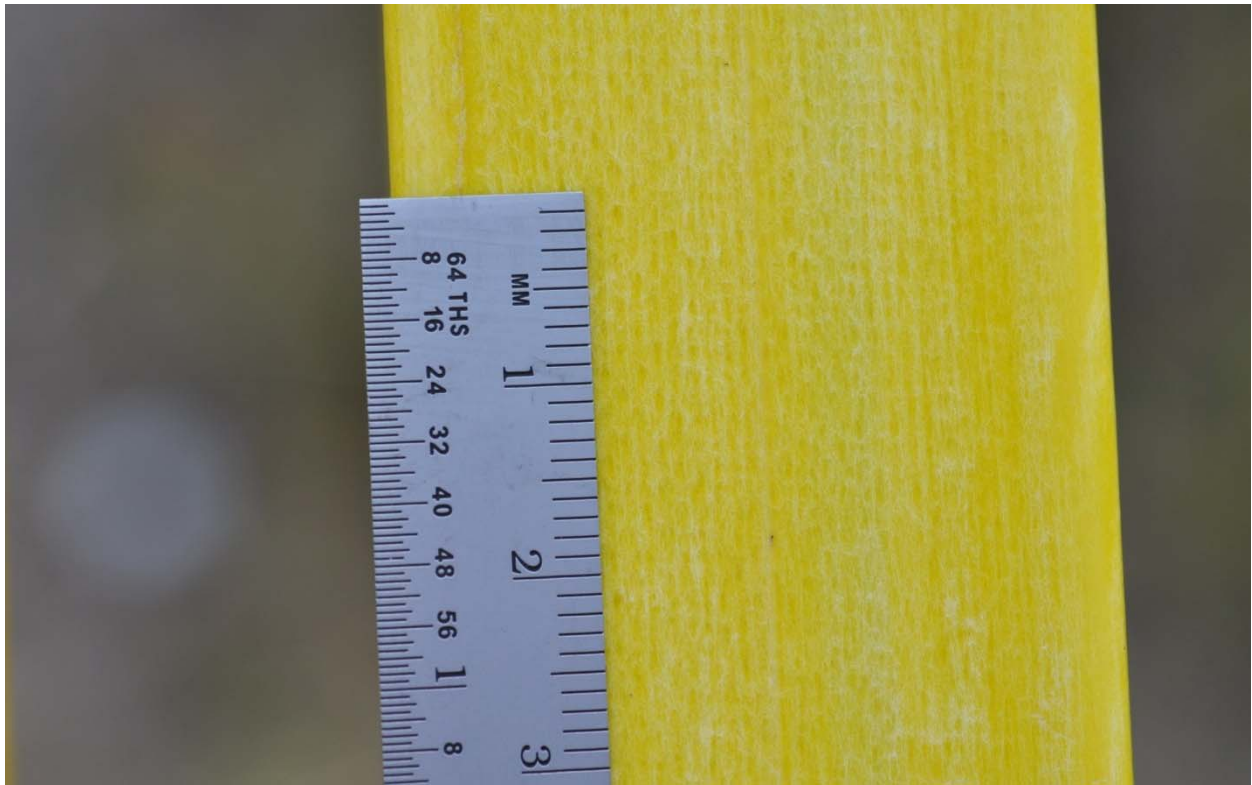
FRP	25%	UV	Discoloring due to UV exposure on the face of the railing that faces the sun

Figure B97. FRP Railing Coupon

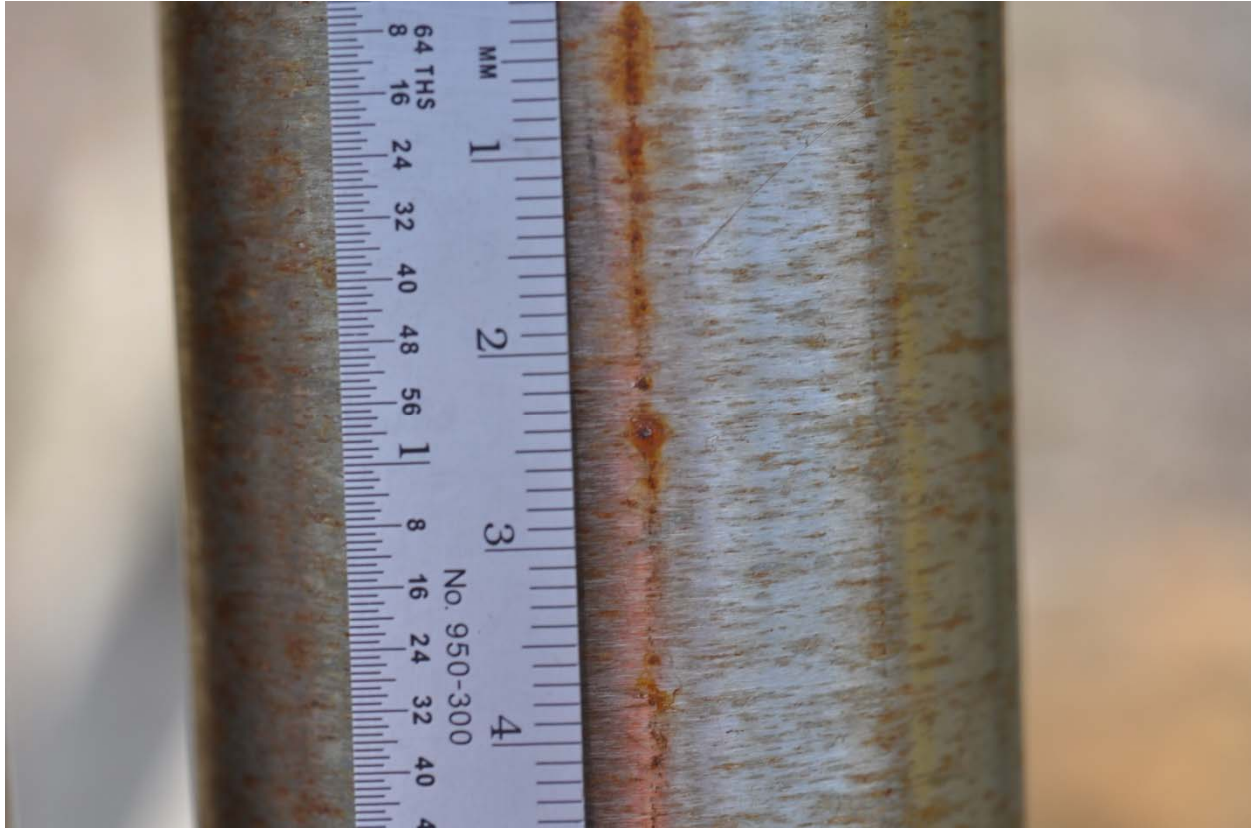
Aluminized Steel	20%	Oxidation	White oxidation of the zinc/AL coating 95% white corrosion on Galv. Hardware
	Fuse Bonded PVC Coated Galvanized	<5%	Rust	Minor rust has begun to form around cut ends and damaged areas
<b>Railing Coupons</b>	Stainless Steel	80%	Oxidation	Surface oxidation has discolored the material.
	Aluminum	<5%	Pitting	Pitting has begun in areas where the anodize may have been damaged
	Coated Steel	10%	Rust	Rust has begun to form where the coating has failed. Discoloring of the coating due to the rust.
	FRP	25%	UV	Discoloring due to UV exposure on the face of the railing that faces the sun
<b>Fabricated Railing</b>	Stainless Steel	50%	Oxidation	Surface oxidation has discolored the material. T-fittings show 90% surface corrosion likely due to lack of passivation.
	Aluminum	<5%	Pitting	Pitting has begun in areas where the anodize may have been damaged
	Coated Steel	20%	Rust	Rusting areas have spread larger causing blistering under the coating.

*Figure B101. Stainless Steel Coupon*

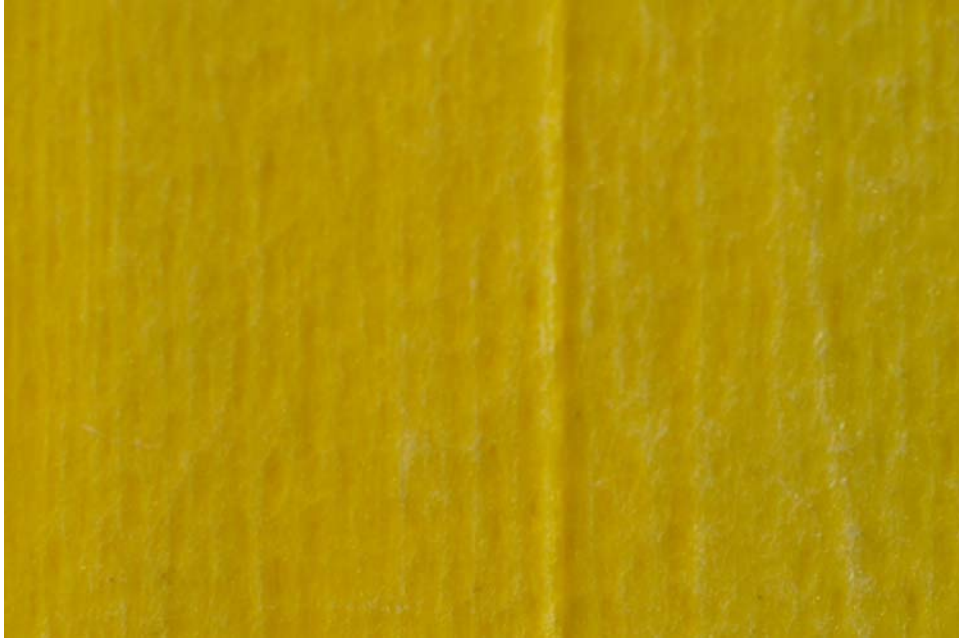
*Figure B117.* FRP Railing Coupon

FRP	25%	UV	Discoloring due to UV exposure on the face of the railing that faces the sun

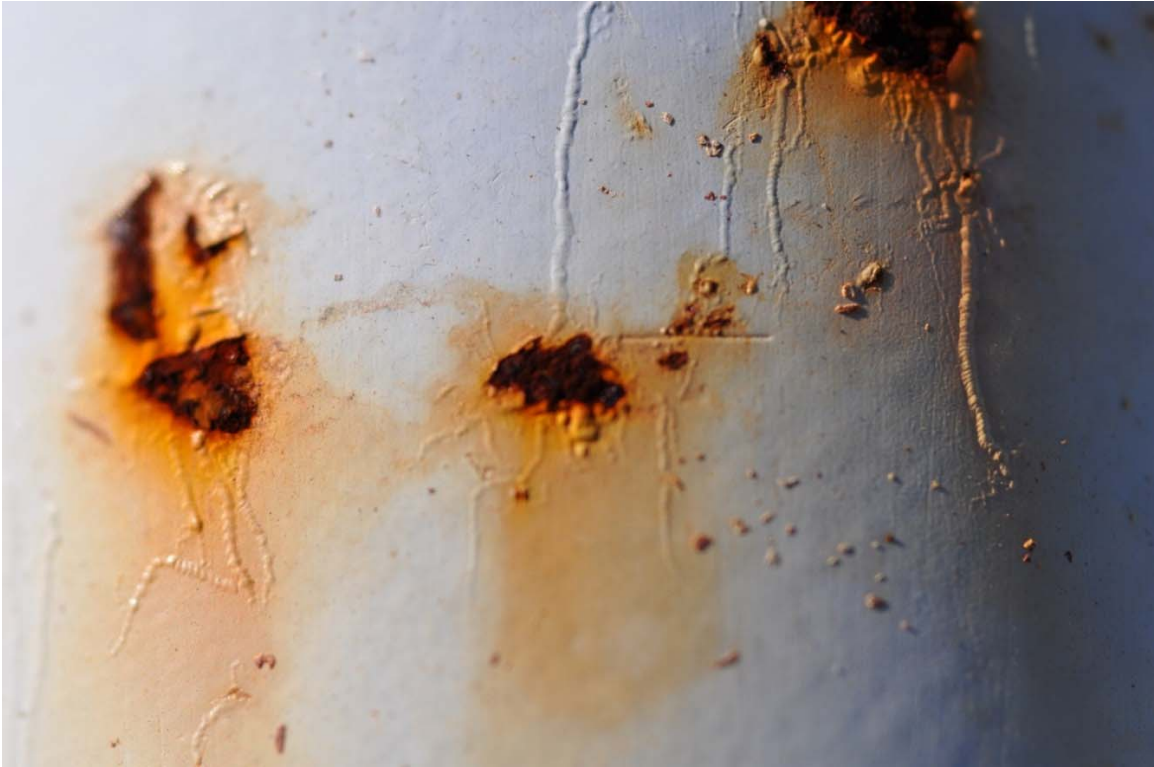
*Figure B119. Coated Steel Coupon*

Aluminized Steel	20%	Oxidation	White oxidation of the zinc/AL coating 95% white corrosion on Galv. Hardware
	Fuse Bonded PVC Coated Galvanized	<5%	Rust	Minor rust has begun to form around cut ends and damaged areas
<b>Railing Coupons</b>	Stainless Steel	80%	Oxidation	Surface oxidation has discolored the material.
	Aluminum	<5%	Pitting	Pitting has begun in areas where the anodize may have been damaged
	Coated Steel	20%	Rust	Rust has begun to form where the coating has failed. Discoloring of the coating due to the rust.
	FRP	25%	UV	Discoloring due to UV exposure on the face of the railing that faces the sun
<b>Fabricated Railing</b>	Stainless Steel	50%	Oxidation	Surface oxidation has discolored the material. T-fittings show 90% surface corrosion likely due to lack of passivation.
	Aluminum	<5%	Pitting	Pitting has begun in areas where the anodize may have been damaged
	Coated Steel	20%	Rust	Rusting areas have spread larger causing blistering under the coating.

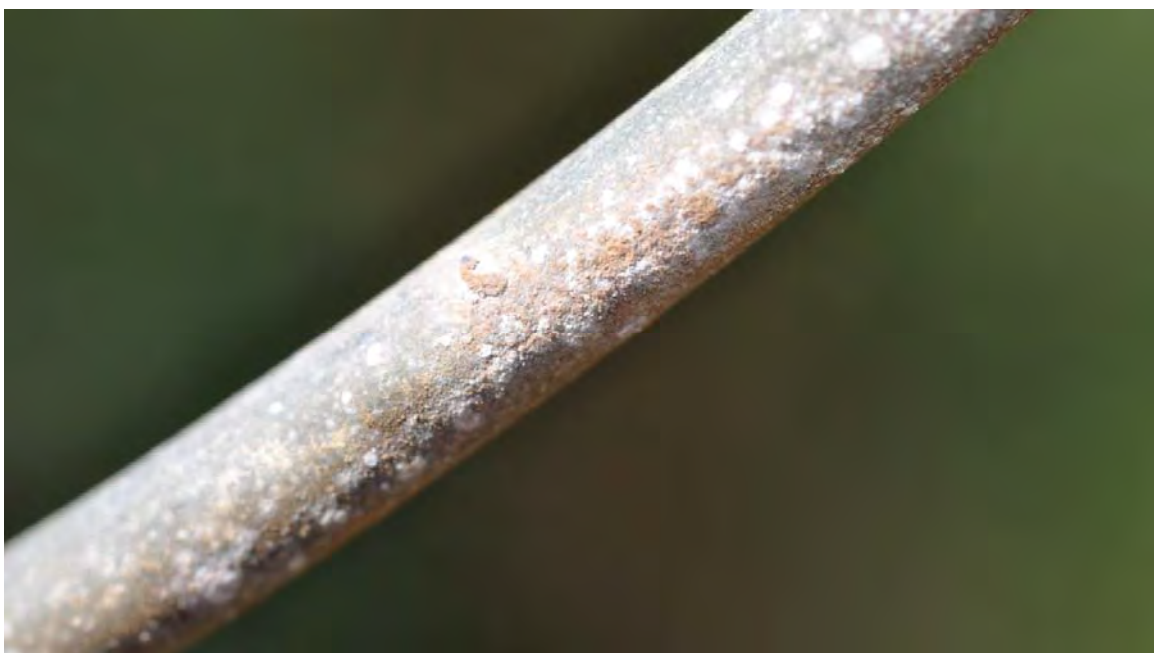
*Figure B135. Galvan Wire Fencing*

Visual Inspection Report				
<b>Date:</b> 1/25/2011 <b>Location:</b> Kahuku, HI <b>Exposure Period:</b> 12 Months				
	Material	% of Surface Corroded	Type of Corrosion	Notes
<b>Fence Wire Coupons</b>	Standard PVC Coated Galvanized	0%	N/A	No visible corrosion
	Fuse Bonded PVC Coated Galvanized	0%	N/A	No visible corrosion
	Standard Galvanized	50%	Oxidation/ Rust	50% of the corrosion areas have degraded past the sacrificial zinc coating and have begun to rust.
	Stainless Steel	100%	Oxidation	Surface oxidation
	Aluminum	5%	Pitting	Minor pitting
	Galvan	75%	Oxidation/ Rust	50% of the corrosion areas have degraded past the sacrificial zinc coating and have begun to rust.
	Aluminized Steel	<5%	Oxidation	White oxidation of the zinc/AL coating
<b>Fabricated Fencing</b>	Stainless Steel	100%	Oxidation	Surface oxidation has discolored the material
	Aluminum	5%	Pitting	Pitting more prevalent on the posts
	Galvan	50%	Oxidation	White oxidation of the zinc/AL coating

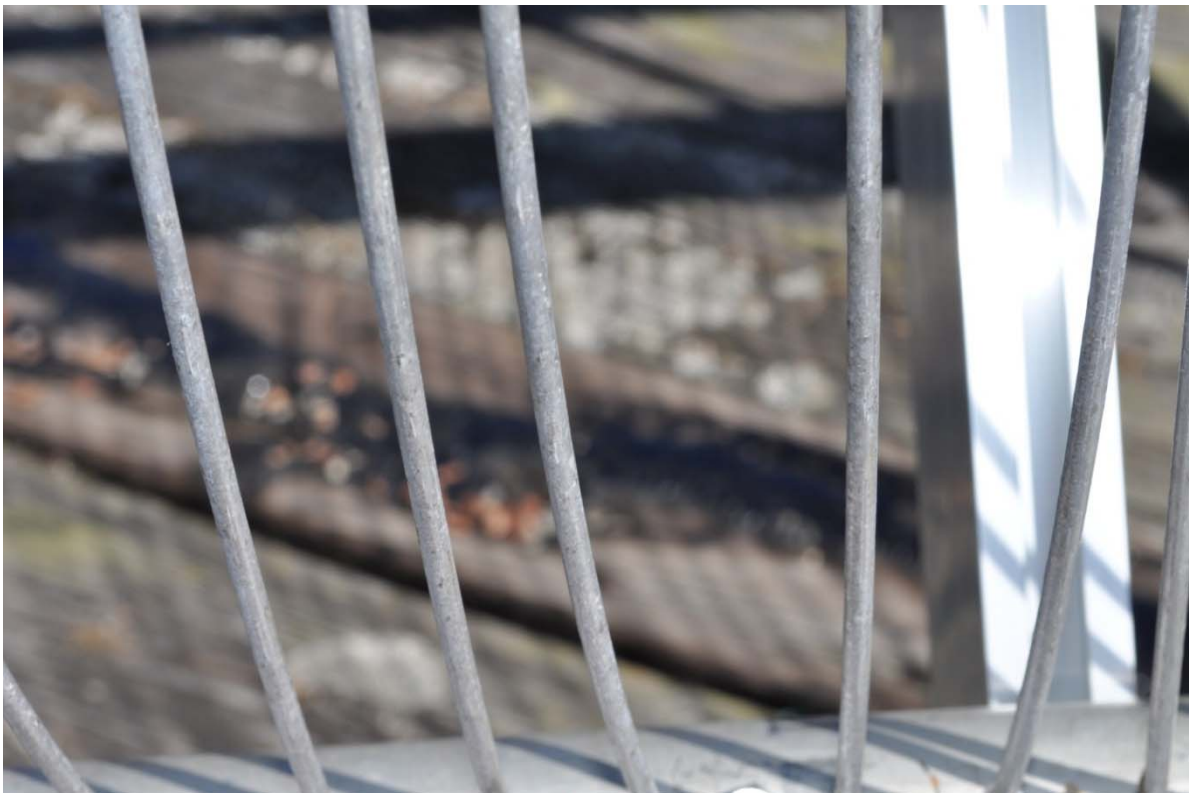
*Figure B143. Aluminized Steel Wire Coupon*

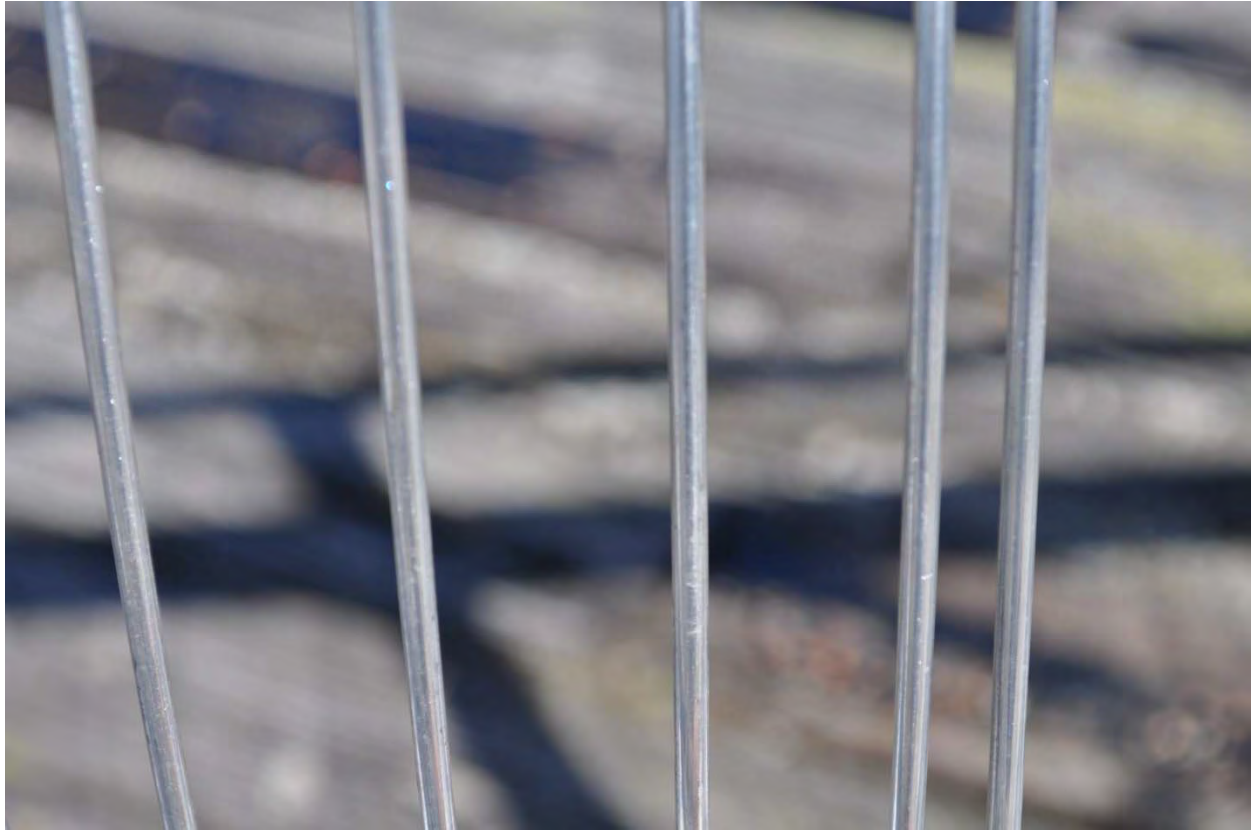
*Figure B144. Aluminum Wire Coupon*

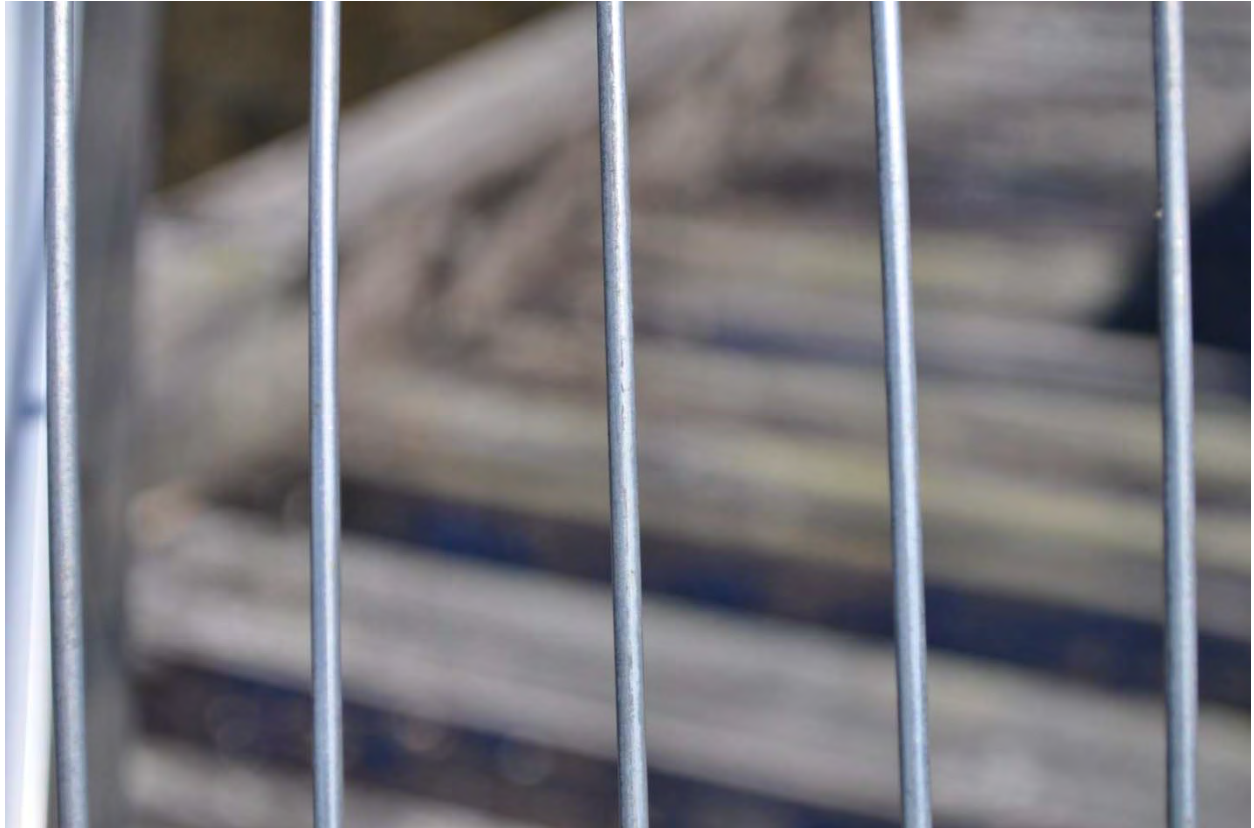
*Figure B146. Standard Galvanized Wire Coupon*

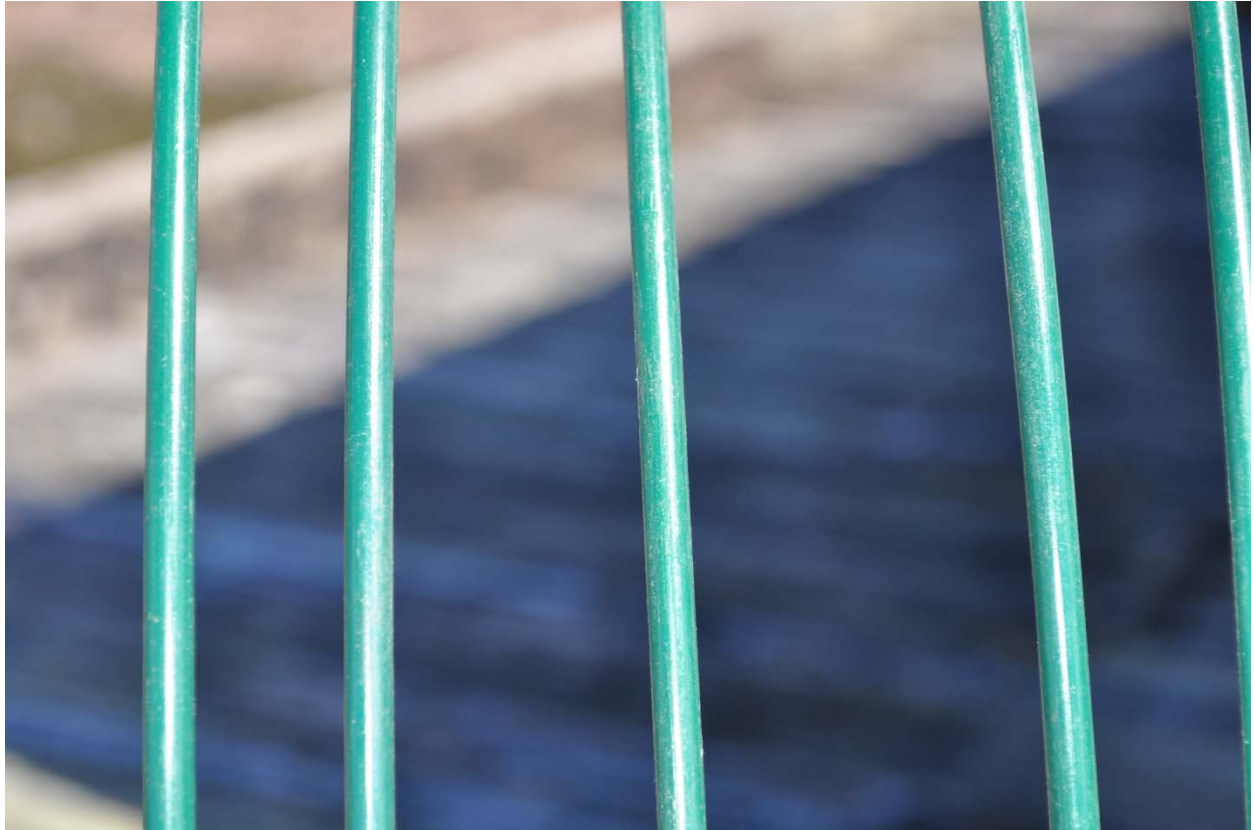
*Figure B148. Standard PVC Coated Galvanized Wire Coupon*

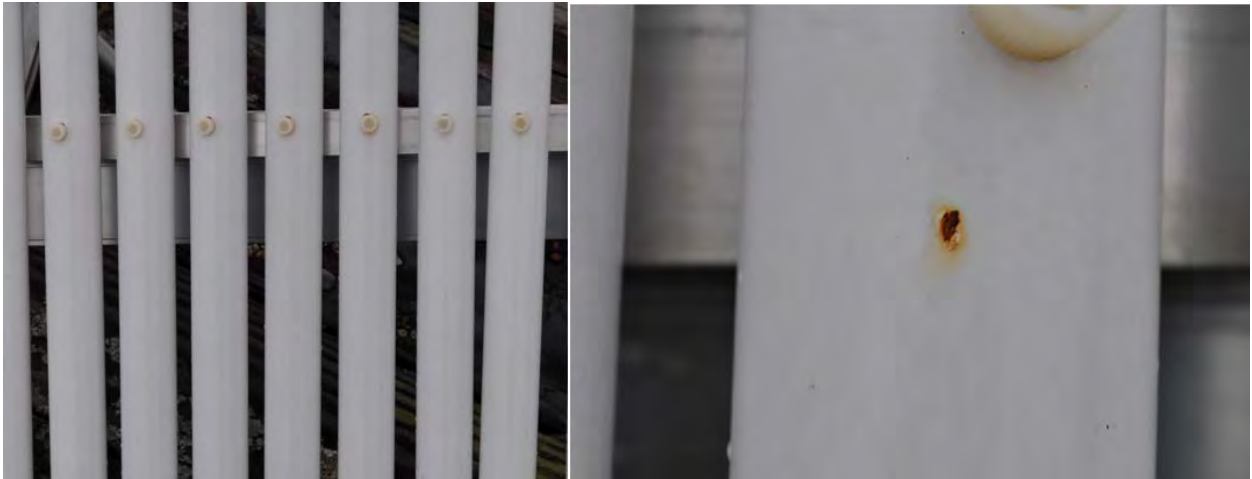
*Figure B150. Coated Steel Coupon*

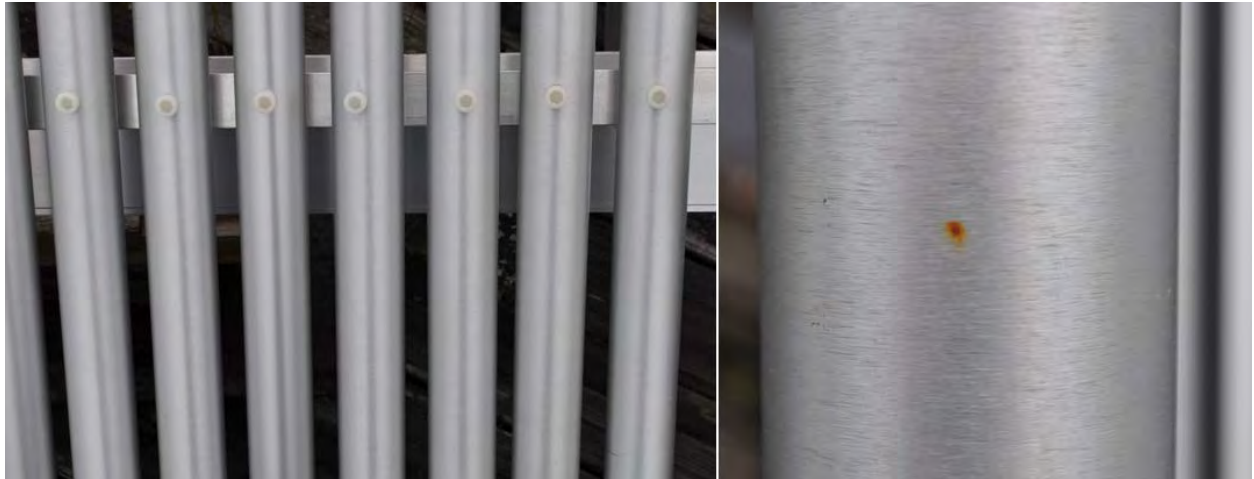
*Figure B152. Aluminum Railing Coupon*

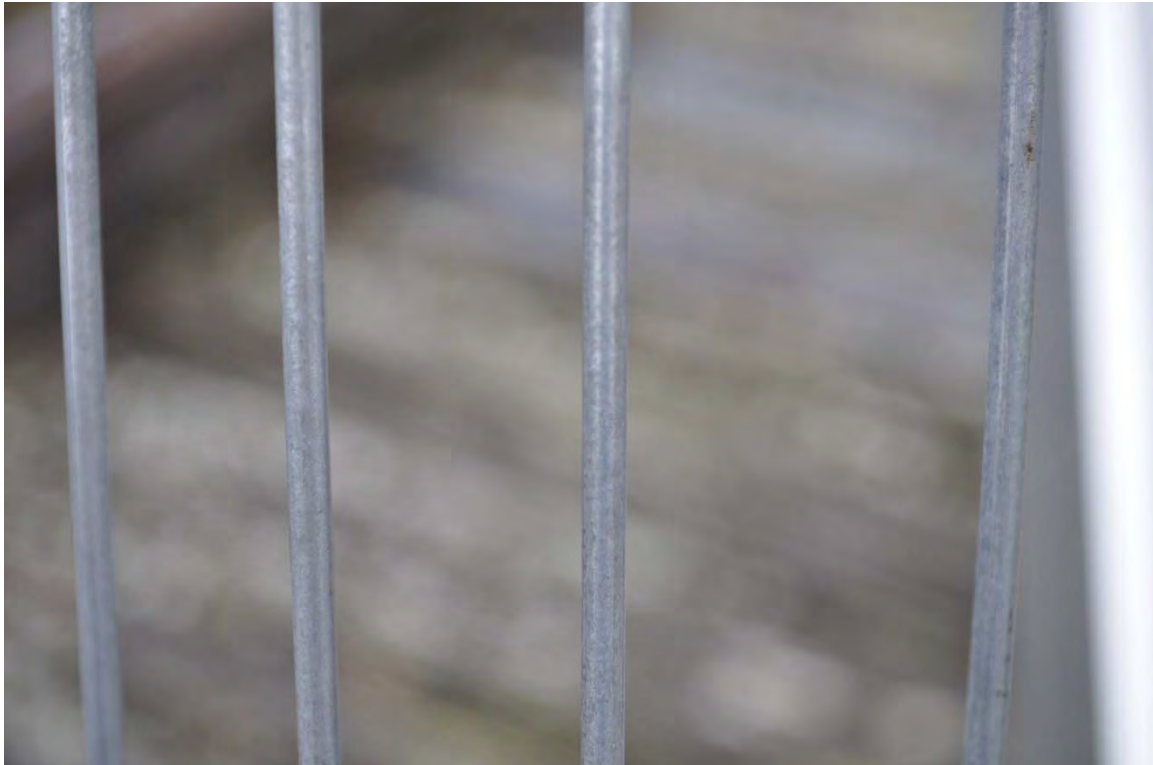
*Figure B154. Standard Galvanized Wire Coupon*

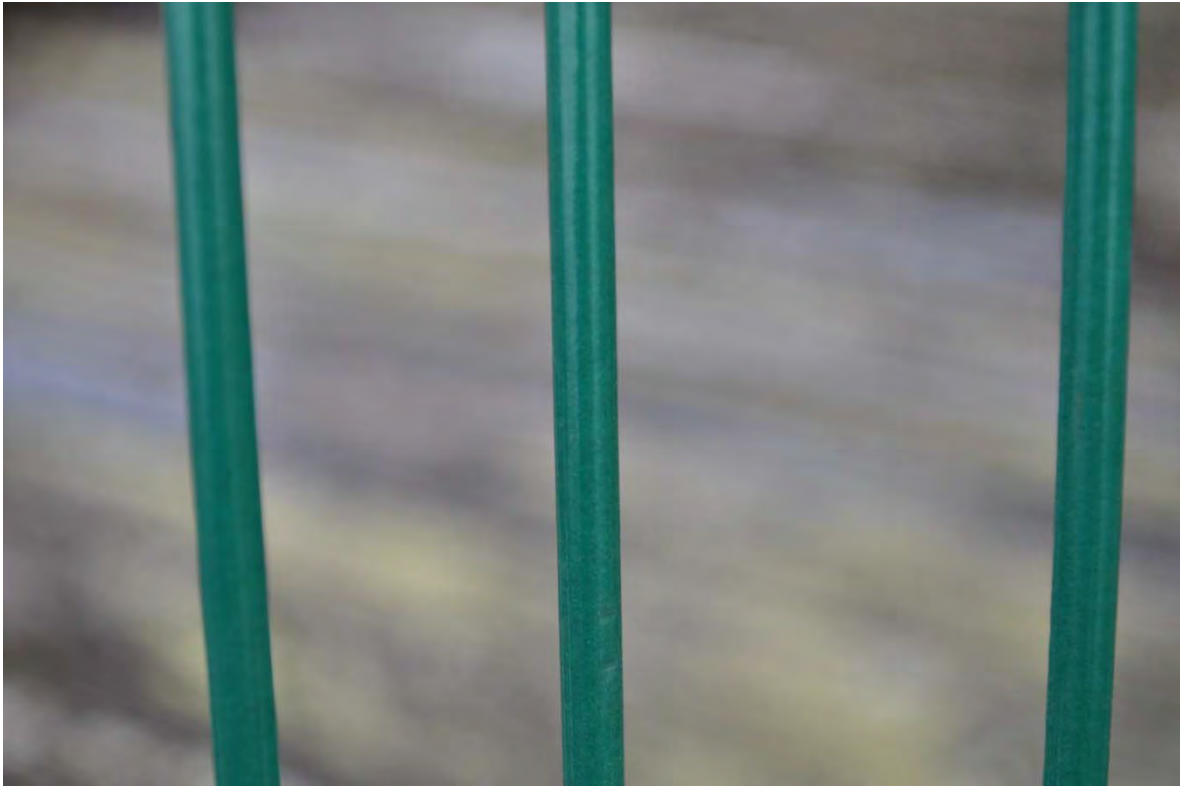
*Figure B156. Fuse Bonded PVC Coated Galvanized Wire Coupon*

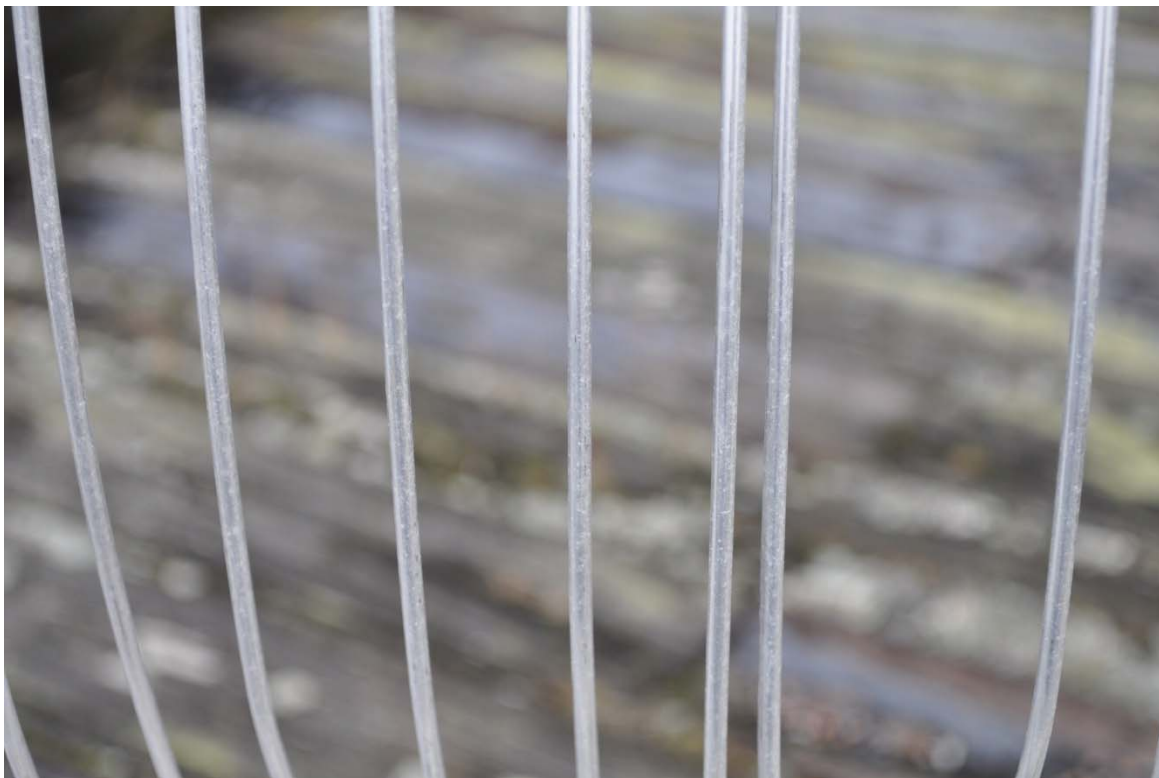
*Figure B157. Aluminum Wire Coupon*

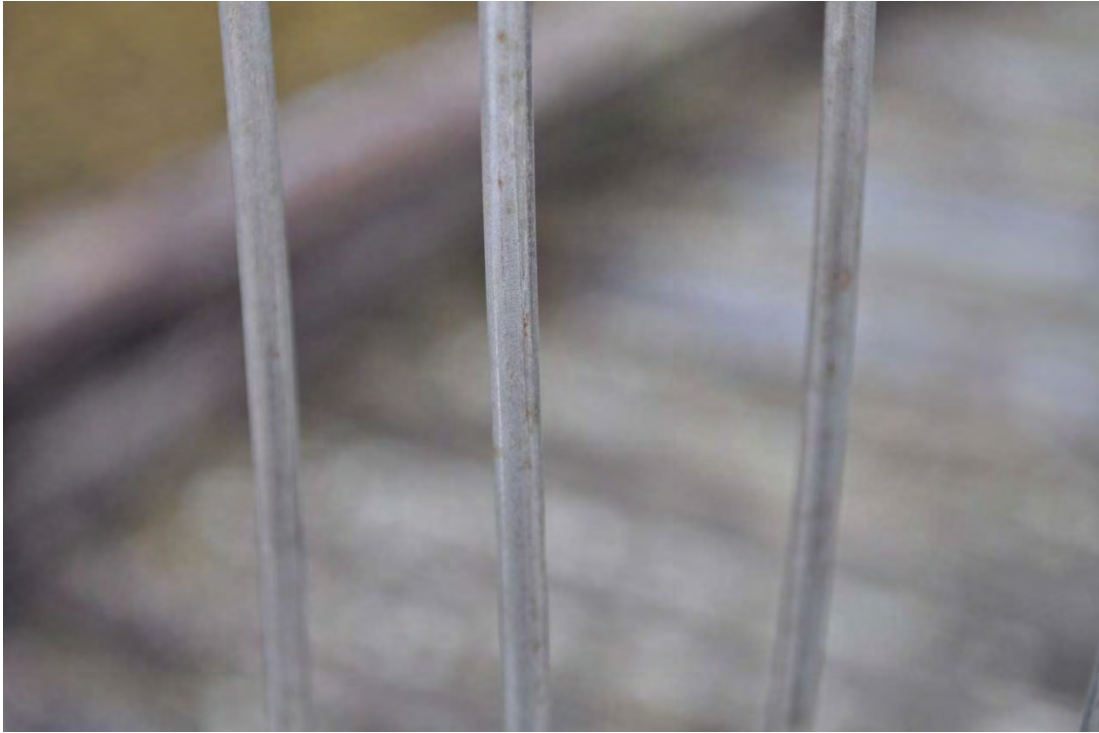
*Figure B158. Stainless Steel Wire Coupon*

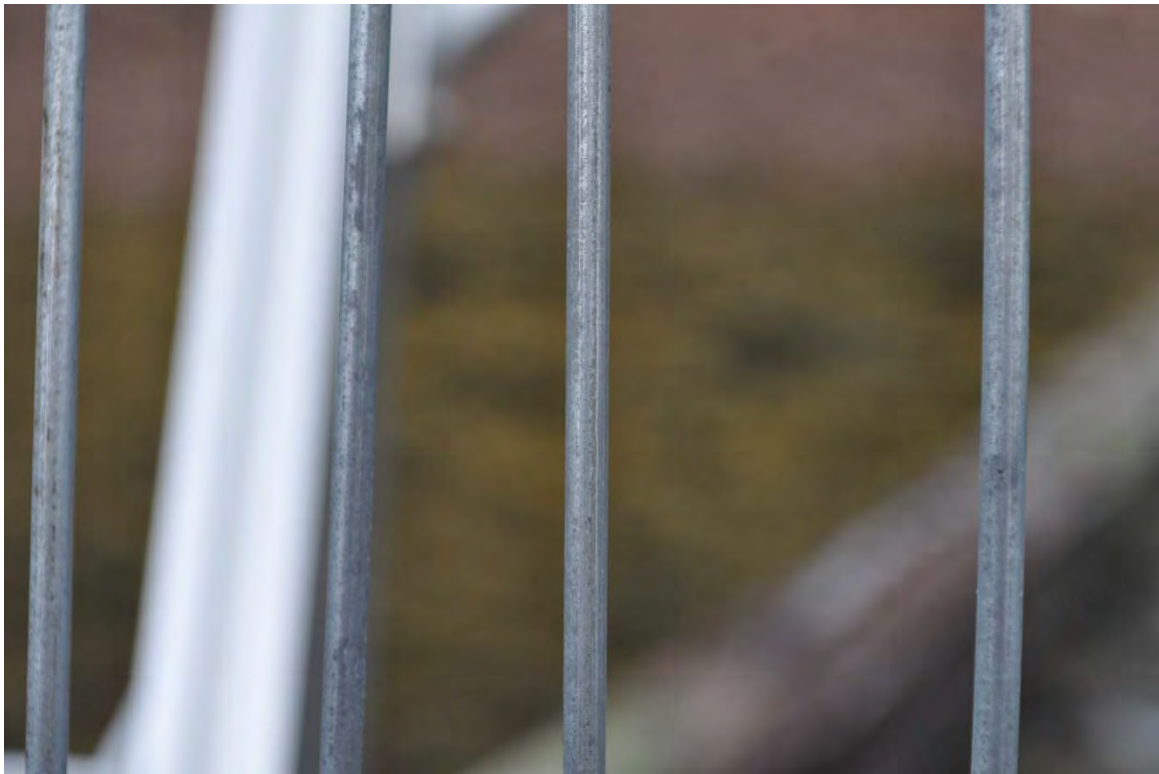
*Figure B159. Galvan Wire Coupon*

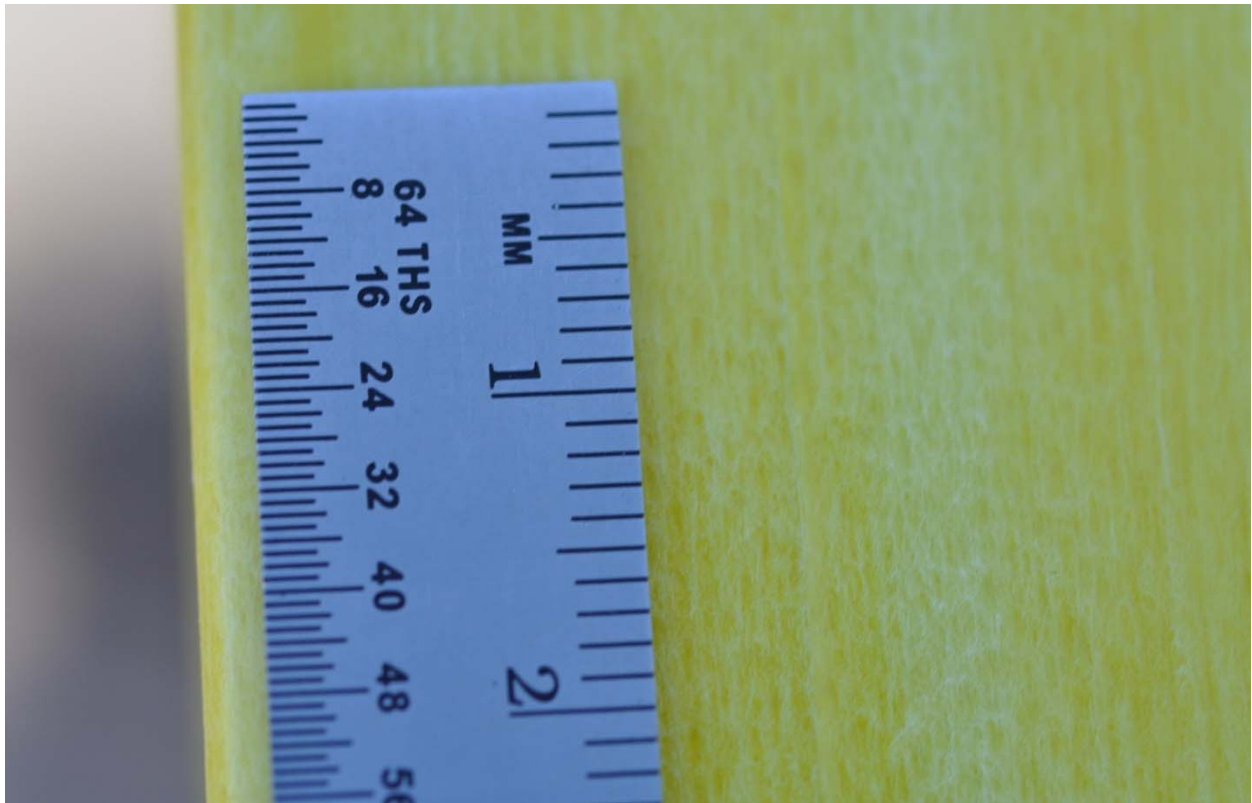
Figure B160. FRP Railing Coupon

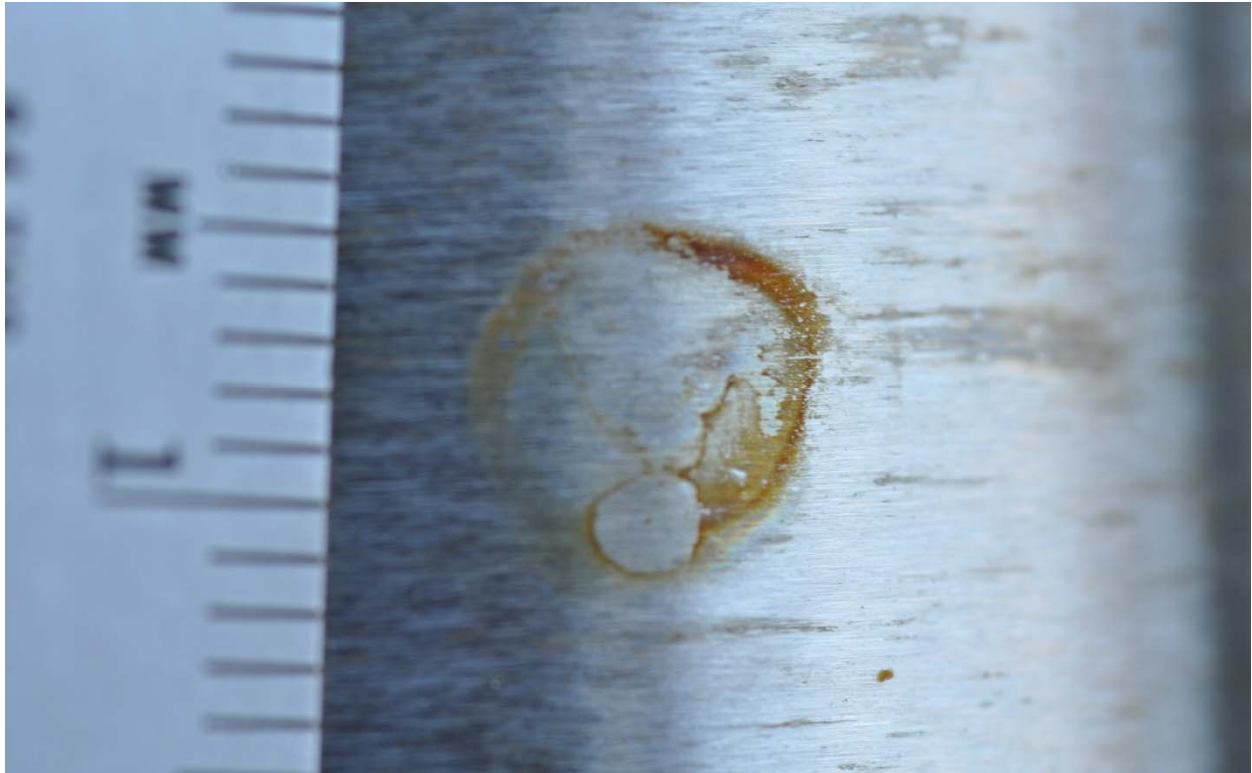
Figure B162. Stainless Steel Coupon

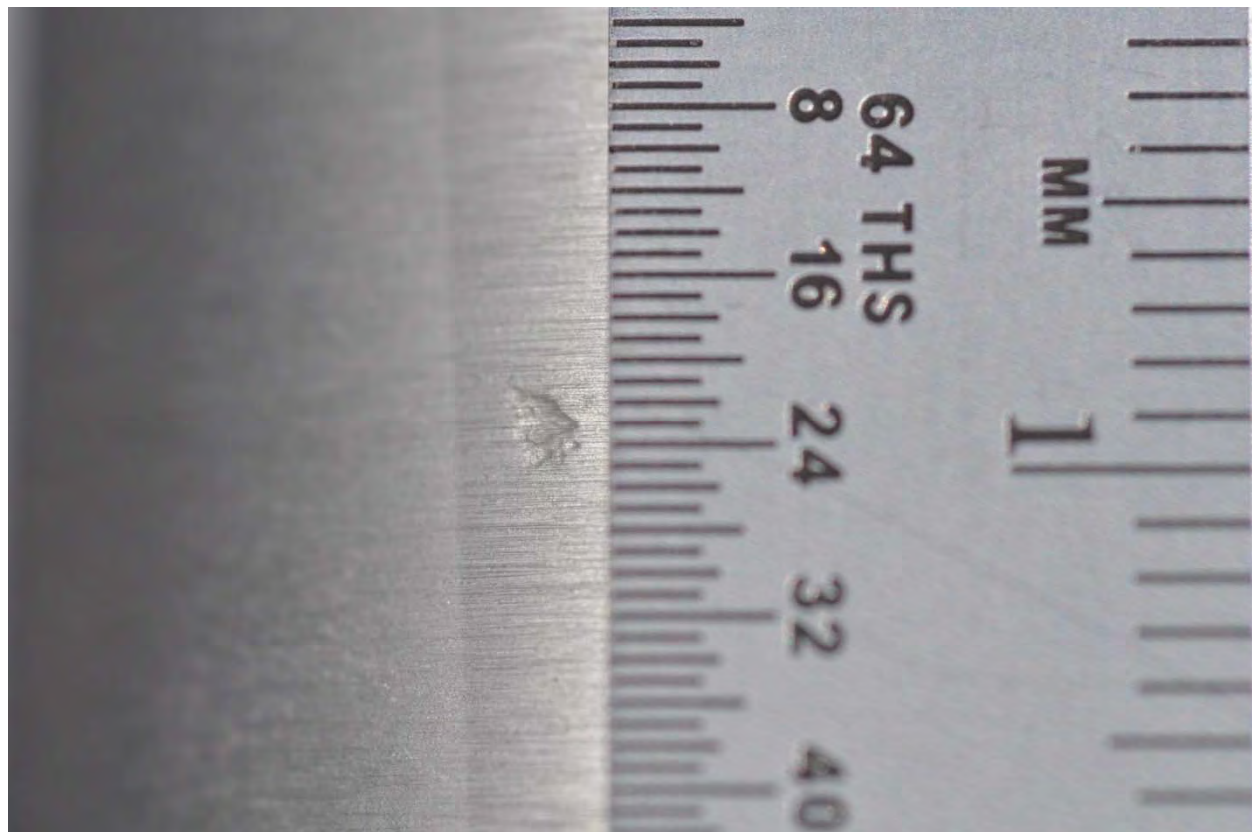
Figure B163. Aluminum Railing Coupon

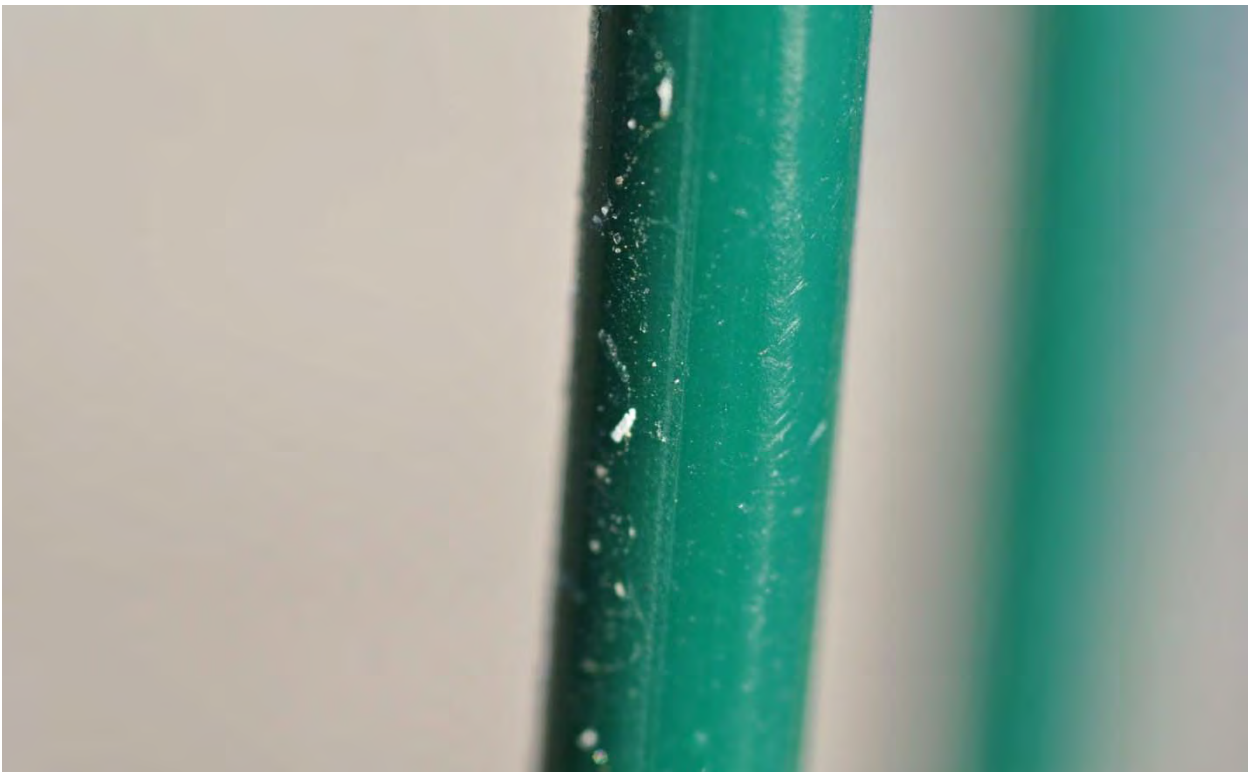
Each wire coupon had visible deposit of chlorides from the salt water environment.

*Figure B167. Fuse Bonded PVC Coated Galvanized Wire Coupon*
